**DEPARTMENT OF CONSERVATION**

DIVISION OF MINES AND GEOLOGY

May 20, 1998

RE: Mapping and Observations at Mission Peak Landslide by Division of Mines and Geology

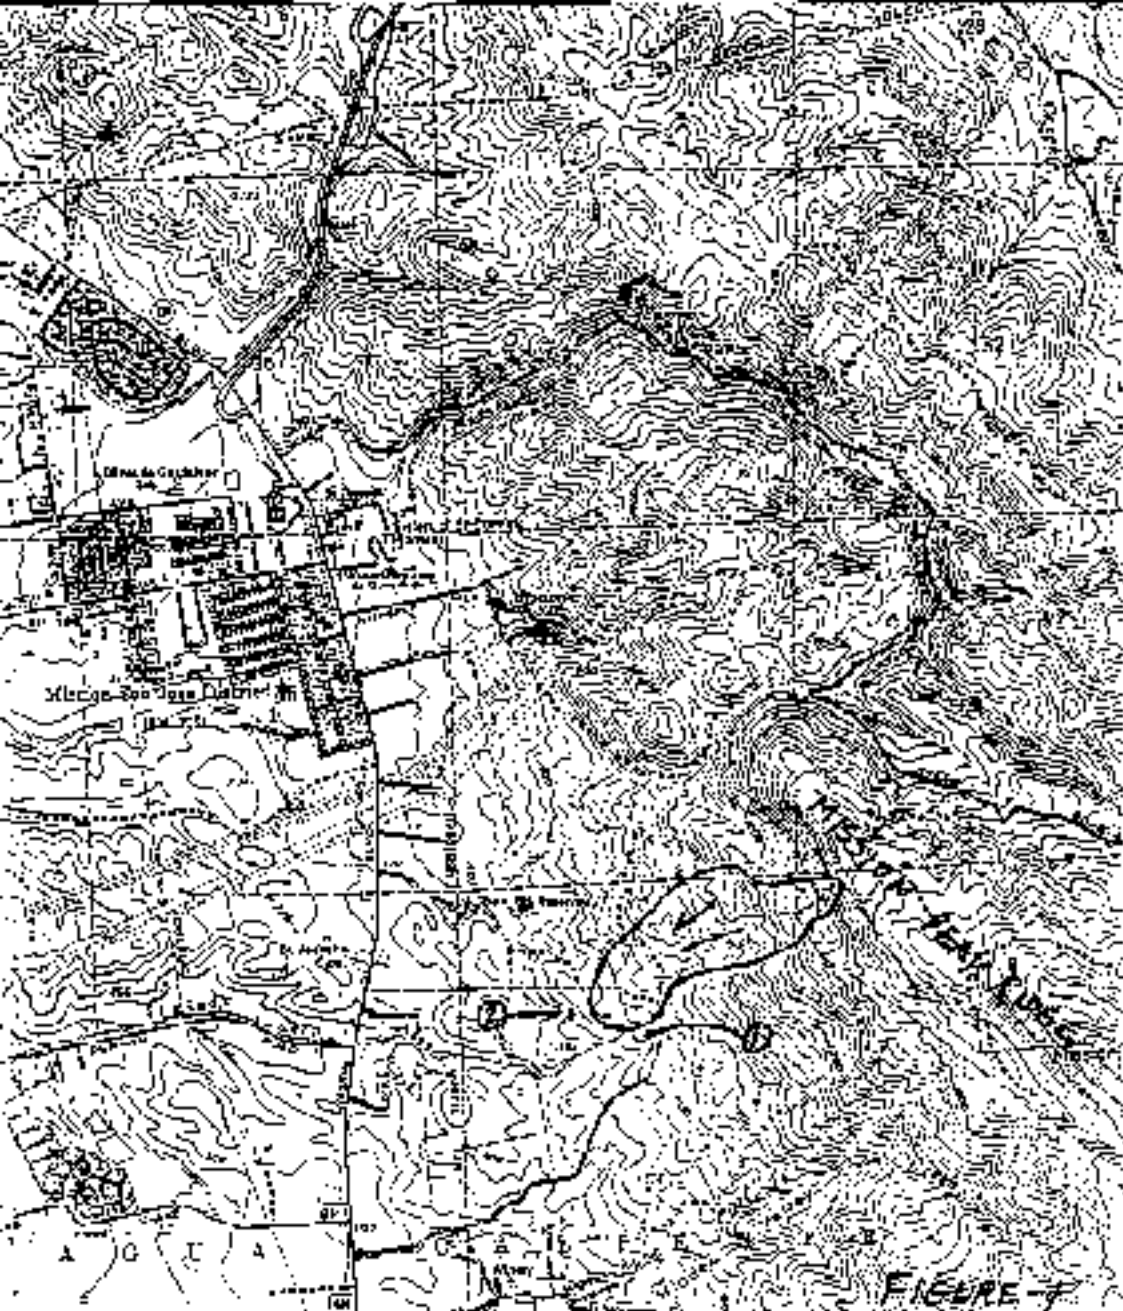
FIGURE 7

flank, on the former Hammer property and extending northeastward (see location 2 on Figure 1). Reconnaissance mapping also confirmed substantial movement of the slide toe into the channel of Aliso Creek to the west of the Mei's property.

Location Map of the Mission Peak Landslide - Fremont, California.  
 Shown on base map of 1961 topographic map of the Niles 7 1/2 minute  
 quadrangle, scale 1:24,000. ①=Mei's House ②=Hammer Property

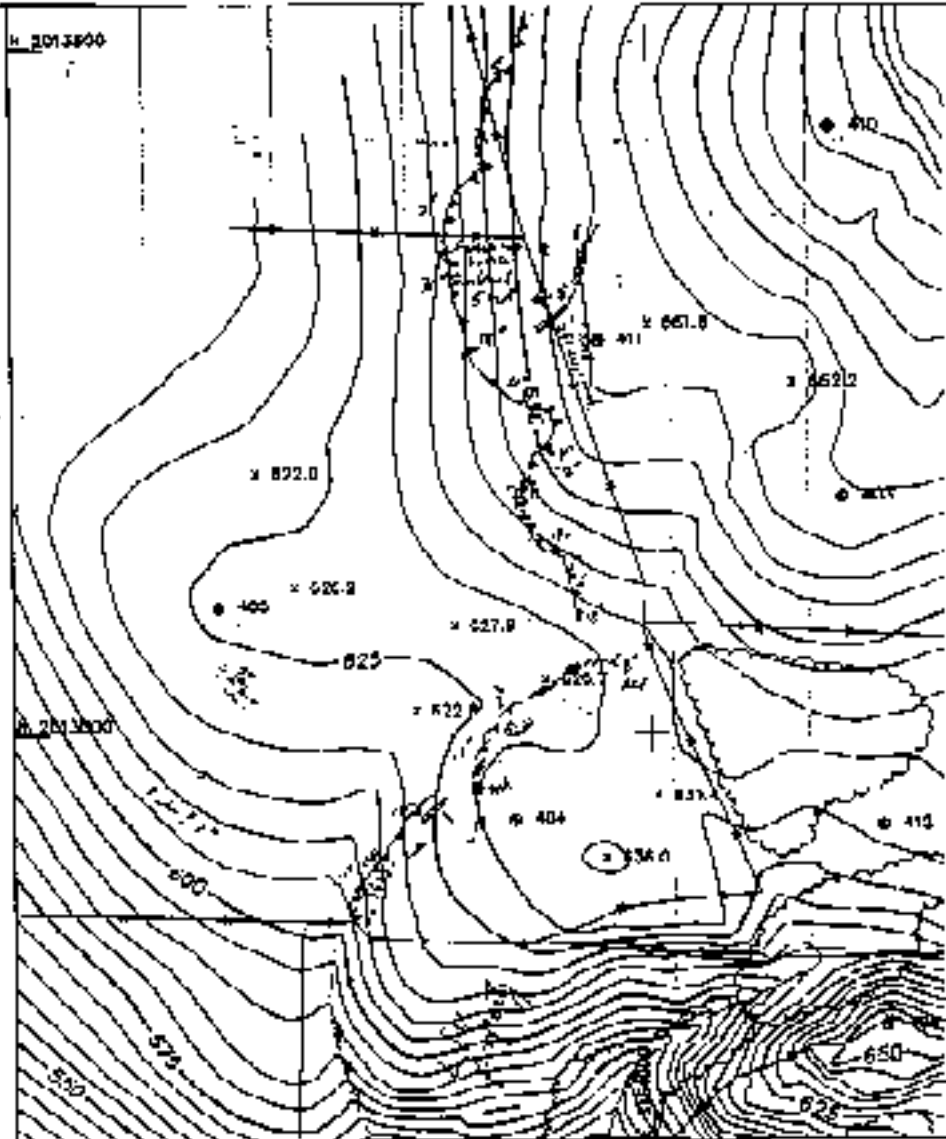
FIGURE-2  
(page 1)

Schlosser's mapping of slide features in the toe area (see Figure 2) included careful recording on a large scale topographic base map of the location and azimuth of linear features such as cracks, backthrusts, and toe thrusts. The mapping will help Rogers analyze conditions in the toe area and determine what is going on in the landslide block to the north of Aliso Creek and what the effects will be on the block to the south that supports the Mei's house.
